St Peter's Church, Malacca

(ARCHITECT'S STATEMENT)

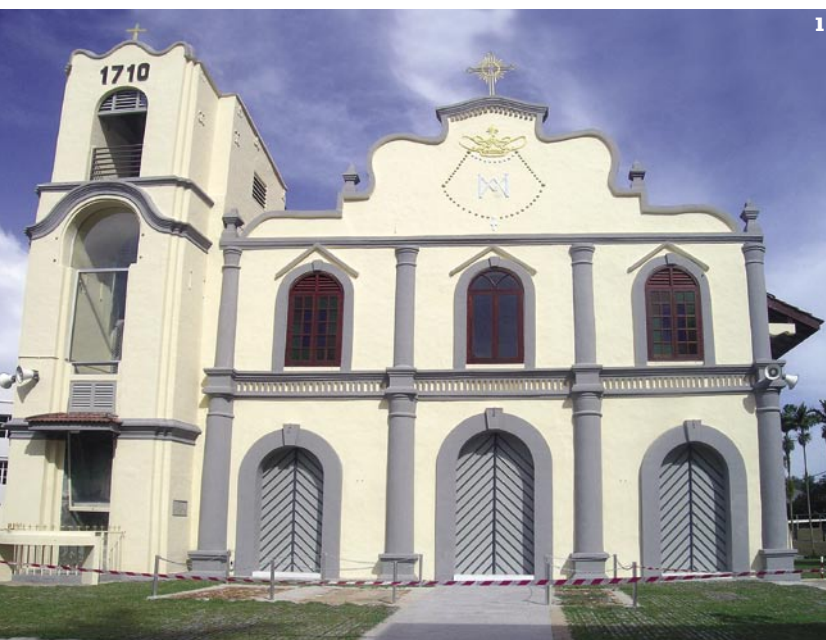
- 1 The new façade of St Peter's Church
- 2 Column before renovation
- 3 Restored column
- 4 Stained glass
- 5 Ceiling & lighting of the church
